DSTO-TN-0073

Experimental Stress Analysis of a Plate
Containing an Elongated Hole to
Determine Buckling Behaviour Under
Representative F-111C Loading
Conditions

**Airframes and Engines Division
Aeronautical and Maritime Research Laboratory**

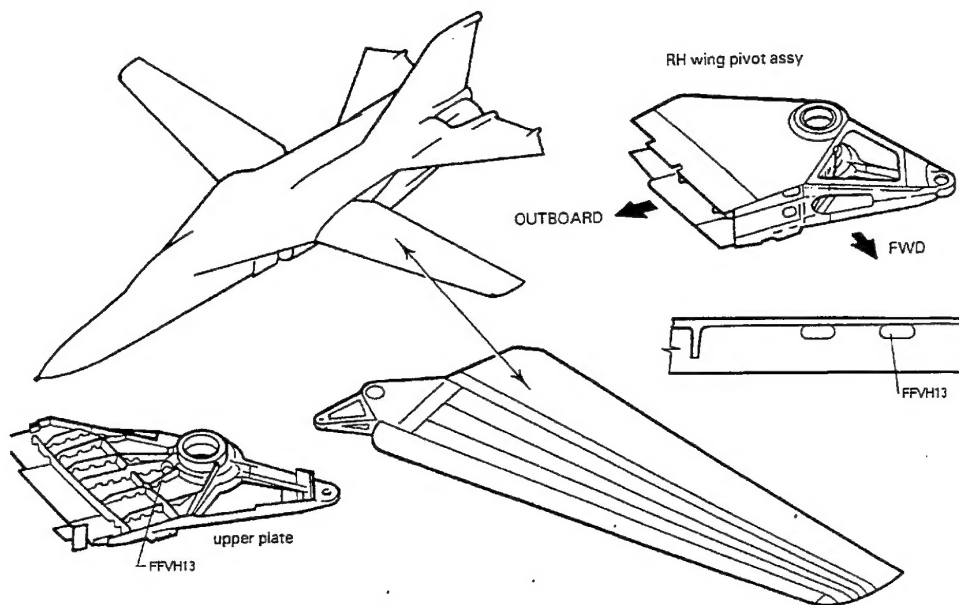
Figure 1: F-111 Aircraft & wing, showing location of critical hole, FFVH13

AMRL has been tasked by the RAAF to investigate methods of improving the fatigue life of the F-111 airframe. An area of major concern in the F-111 is the wing pivot fitting manufactured from D6ac steel in which there are a number of machined fuel flow vent holes (FFVH). Under Cold Proof Load Tests, one of these holes, number 13, Figure 1, experiences extensive plastic deformation in the lower inboard corner, resulting in tensile residual stresses. These residual stresses are detrimental and, coupled with the remote load sequence, contribute to crack initiation/growth from the affected area. There have been numerous incidents of fatigue cracking at FFVH13 in the wing pivot fitting in the RAAF's F-111 fleet, and the problem could compromise the structural integrity of the fleet out to the planned withdrawal date of 2020.

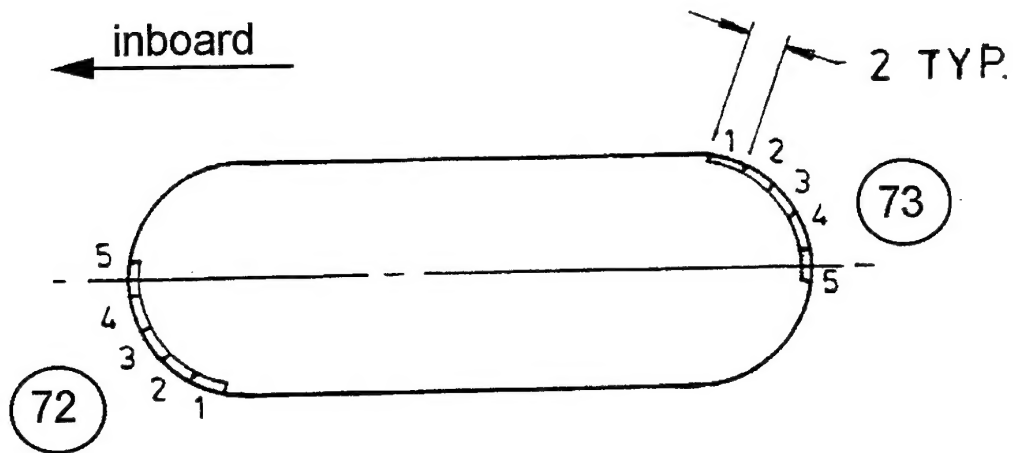
Figure 2: Location of Kyowa strip gauges number 72 & 73 on the bore of FFVH13.

The strain locations relevant to this report were for gauges 72 & 73 in Reference 2 (see Figures 2 & 4). Gauge 72 is the more critical of the two, being at the lower inboard corner of FFVH13, and its output was used as the target for the FFVH13 plate specimen of this report.

The relevant strain gauges used in the Reference 2 survey were Kyowa¹ brand, type KFG-1-120-D9-11N10C2, consisting of five elements each of 1mm length and 2mm pitch with gauge elements parallel to the strip.

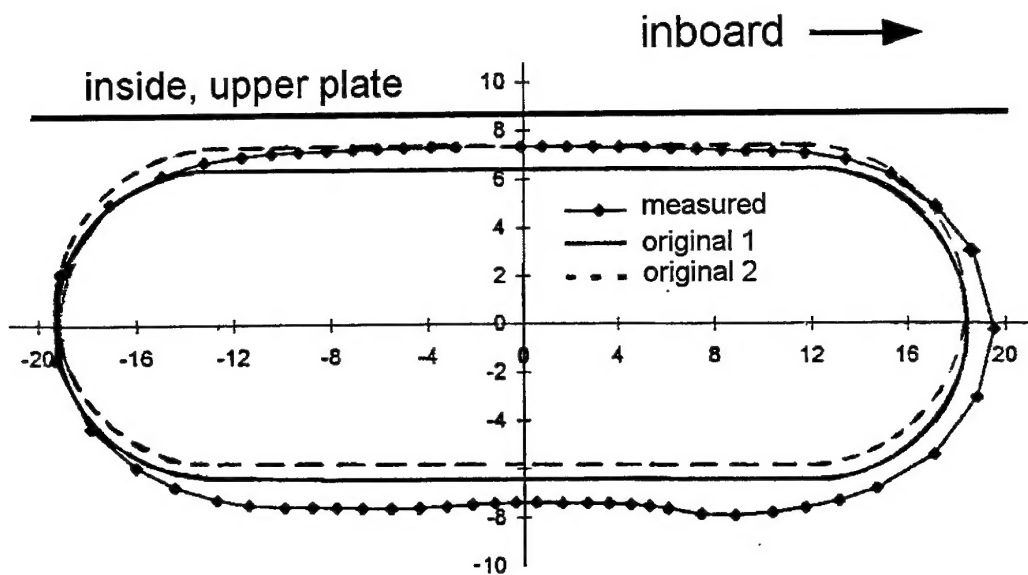
Figure 3: Measured shape of FFVH#13 compared with the original blueprint mousehole shape in two possible locations.

The exact overall dimensions of the FFVH13 in the test wing were recorded in Reference 2 and are presented in Figure 3 compared with two possible blueprint original locations - "original 1" is considered to be the most likely position of the original hole. The nominal blueprint overall dimensions of the hole are 1.5 inch x 0.5 inch (38.1 mm x 12.7 mm). This would mean that a 10 mm long strip gauge would take up the complete quarter radius as shown in Figure 2 and Figure 4, from Reference 2.

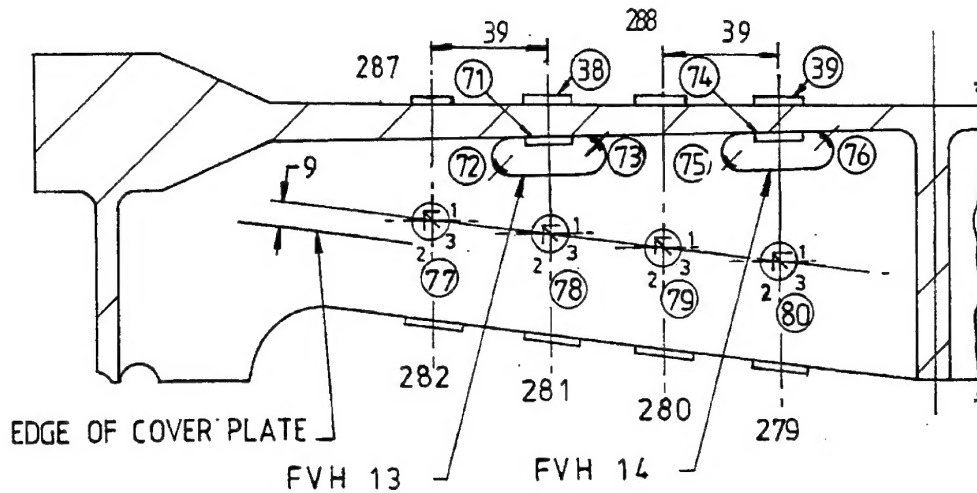
Figure 4: Location of FFVH13 in relationship to the surrounding structure and gauges [3]

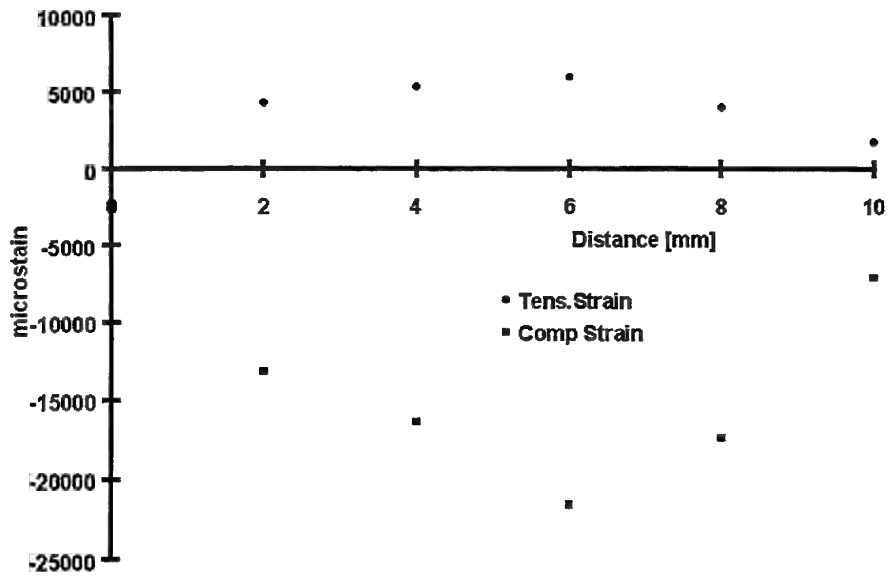
Figure 5: Strains around FFVH13 as a function of distance along strip gauge

Figure 5 presents the wing strain results from Reference 2 for gauge 72 for the two load cases under consideration - CPLT UP (compressive strain) and CPLT DOWN (tension strain). Of interest is that the strains remain all of the same sign for a given load case - something that proved different to the test specimen (Section 6).

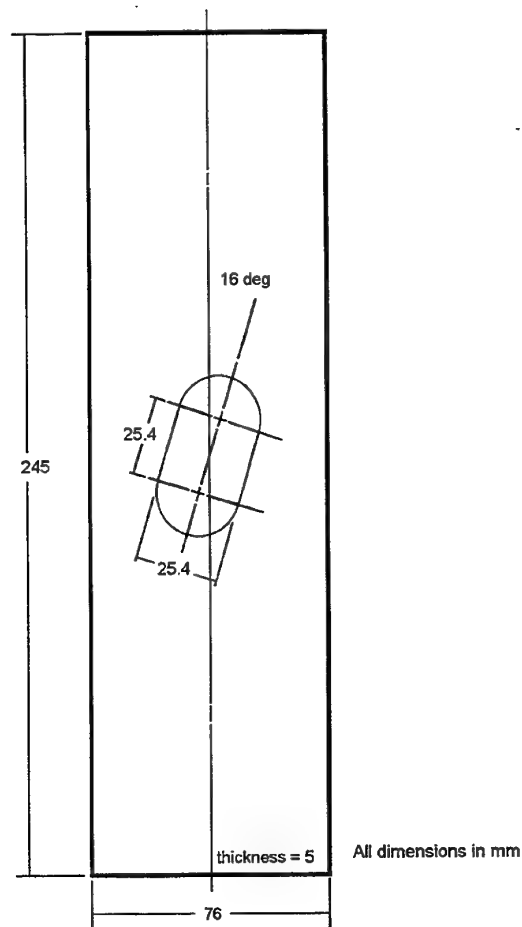
Figure 6: Geometry of test specimen

A test specimen design existed from prior analysis. Figure 6 gives the dimensions of the specimen. The design was such that it would:

1. represent the stresses existing in the FFVH13 (see Reference 4); and
2. represent a plug size that would cover the majority of the current F-111 fleet size and shape configurations of FFVH13.

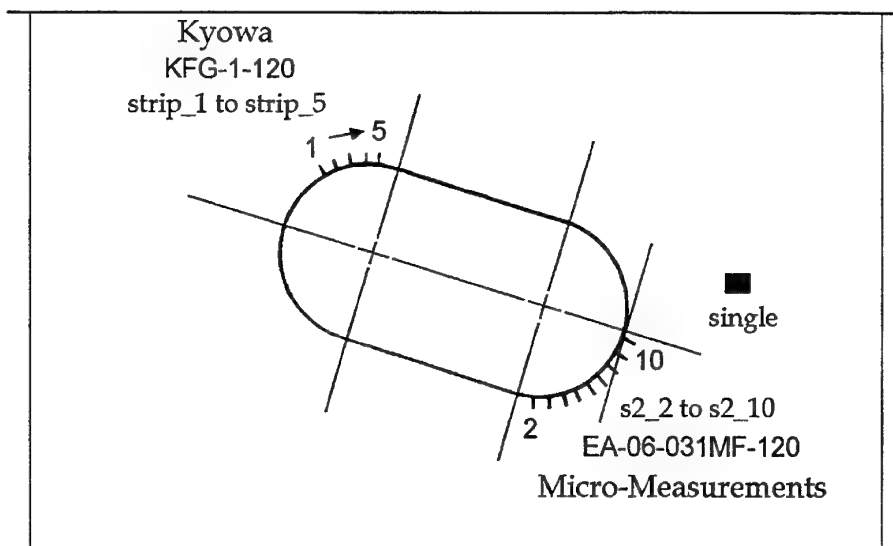
Figure 7: Strain gauge locations on specimen

Strain gauges were fitted to the test specimen as shown in Figure 7. A Kyowa strip gauge is shown in the top left radius of the hole, numbered "strip_1" through to "strip_5". A Micro-Measurements³ strip gauge is shown in the bottom right radius, numbered "s2_1" through to "S2_10". Gauge elements s2_1, s2_3 & s2_6 were inoperative through the test. Elements s2_3 & s2_6 were damaged during installation (Micro-Measurements strip gauges do not come pre-wired and are therefore more susceptible to damage), and s2_2 failed prior to test for an unknown reason. This meant there was no gauge at the critical point in the hole for the MM strip gauge.

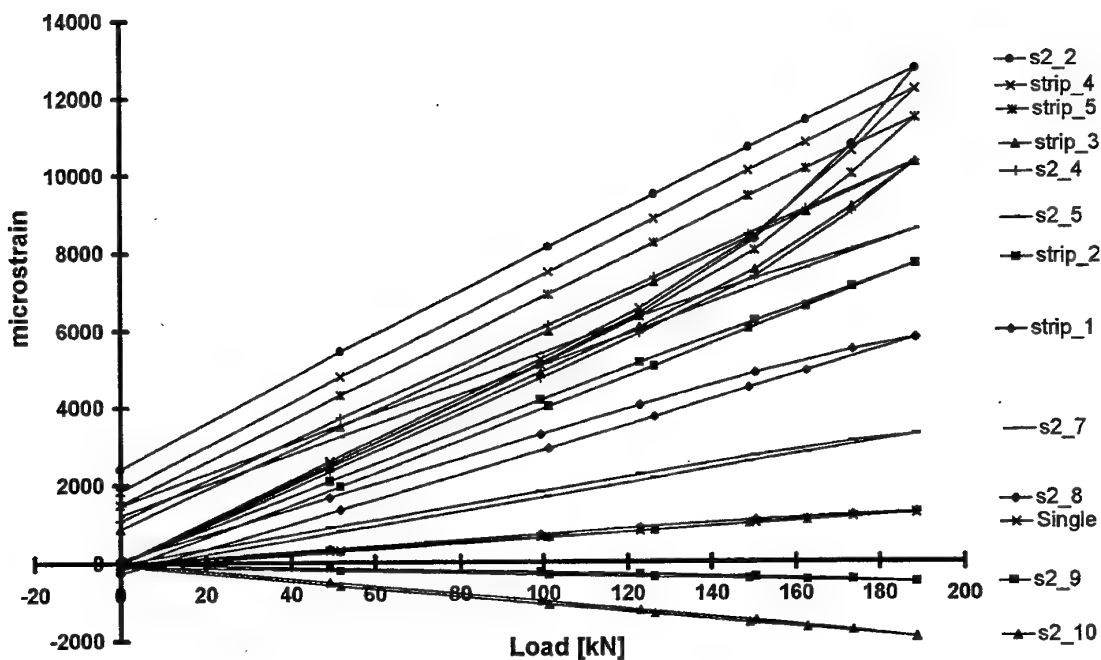
Figure 8: Strain vs load results for all strain gauges during tension loading. Strip_i denoted Kyowa gauges. s2_i denotes Micro-Measurements gauges. The single gauge is a Micro Measurements gauge.

The results for all strain gauges during the tension cycle of the loading are shown in Figure 8.

The Kyowa gauge "strip_4" and the Micro-Measurements gauge "s2_2" gave the highest gauge readings at each location, though these values are unlikely to be the maximum value experienced on the hole radius. The full set of strain data from the

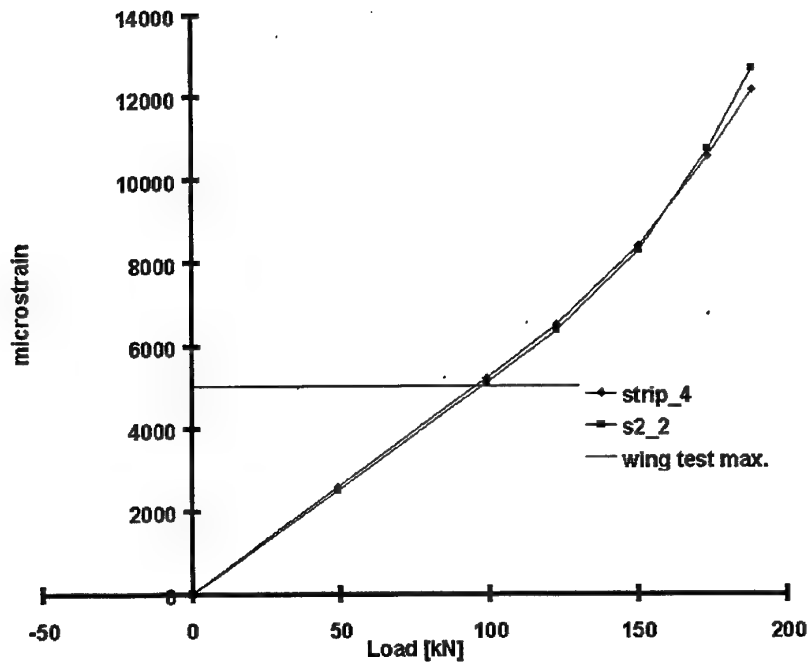
Figure 9: Response of gauges s2_2 and strip_4 during tension loading compared to the maximum seen during wing test in Figure 7.

tension and compression tests is given in Tables 3 and 4. For the tension data in Table 3 the response of these gauges are compared in Figure 9 to the maximum of $5045 \mu\epsilon$ ($= 5998 \mu\epsilon - 953 \mu\epsilon$) seen during the static test of the wing in CPLT DOWN loading case.

From Figure 9, it can be seen that some plasticity exists after about 100kN load, which also corresponds to the point where the wing strain is reached.

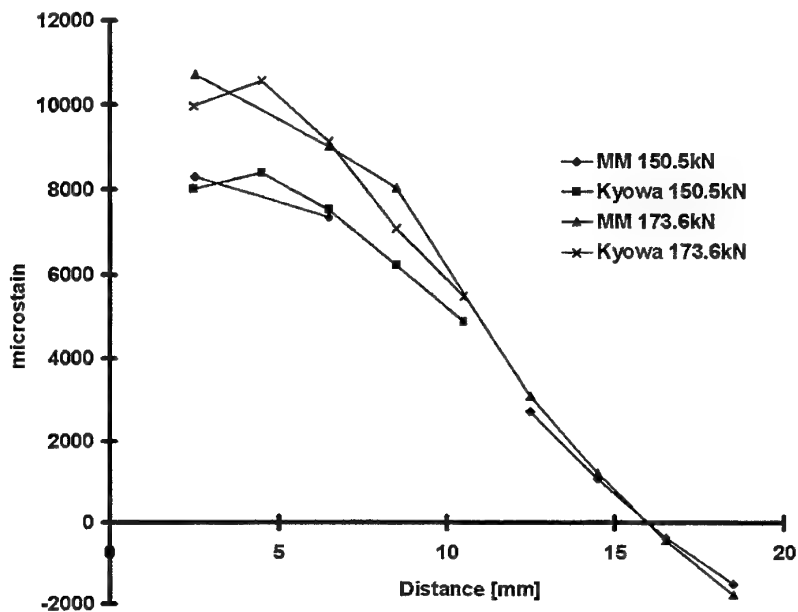
Figure 10: Tension strain versus gauge distance from tangent point - Kyowa & Micro - Measurements strain gauges. Loads 150.5kN & 173.6kN

At the load levels of 150.5kN and 173.6kN, the strain distributions around the hole radii were as shown in Figure 10. This indicates that the Kyowa and Micro-Measurements gauges were giving good correlation to points above yield onset. It also indicates that the strain distribution around the specimen hole goes negative - something that does not occur with the wing strain gauge (compare to Figure 4).

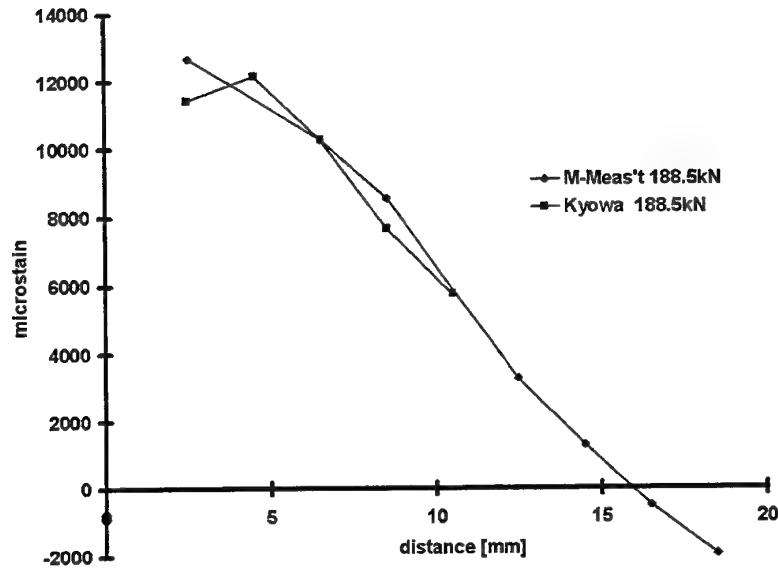
Figure 11: Maximum tension strain versus gauge distance from tangent point - Kyowa & Micro - Measurements strain gauges.

After yielding and at the maximum tensile strain point, the results are shown in Figure 11. This shows that one end of the hole is experiencing higher strains - possibly due to slightly different material properties influencing a different yield onset.

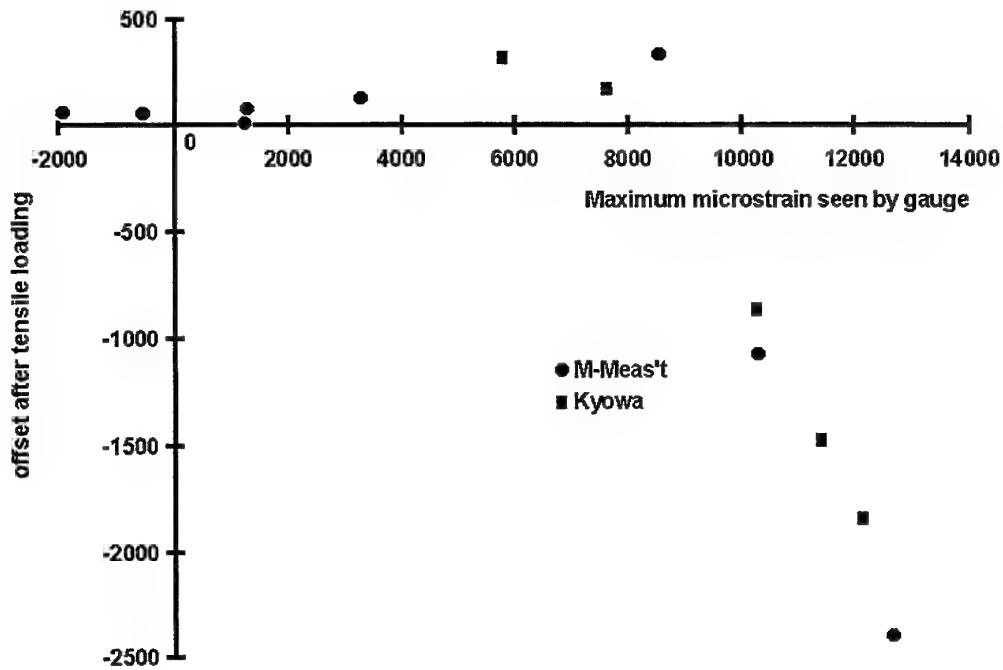
Figure 12: Gauge offset versus maximum strain seen by gauge during tension loading

The reason for using both Kyowa and Micro-Measurements gauges in the same, but opposite locations was to determine the differing (if any) responses of the gauges after removal of the load. Figure 12 plots the gauge offset after removal of the tensile loading. There is no reason to suspect any difference between Kyowa and Micro-Measurements gauges based on this limited information. The compressive cycle is more severe, and could show a difference.

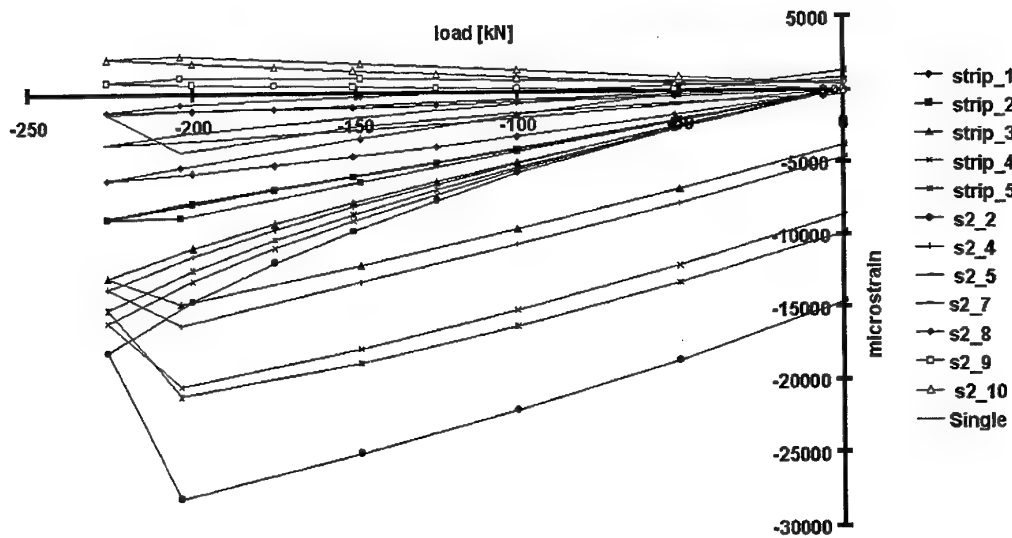
Figure 13: Strain vs load results for all strain gauges during compression loading. Strip_x denotes Kyowa gauges. s2_z denotes Micro-Measurements gauges. The single gauge was a Micro-Measurements gauge.

Gauges were zeroed at the beginning of the compression cycle as the data acquisition system needed to be re-calibrated because of the aforementioned error. Results cannot be looked at in isolation - all gauges having a degree of offset indicated in Figure 8 and Figure 12. Figure 13 presents the strain results during the compressive cycle, with Figure 14 presenting the same data of strains occurring up to buckling.

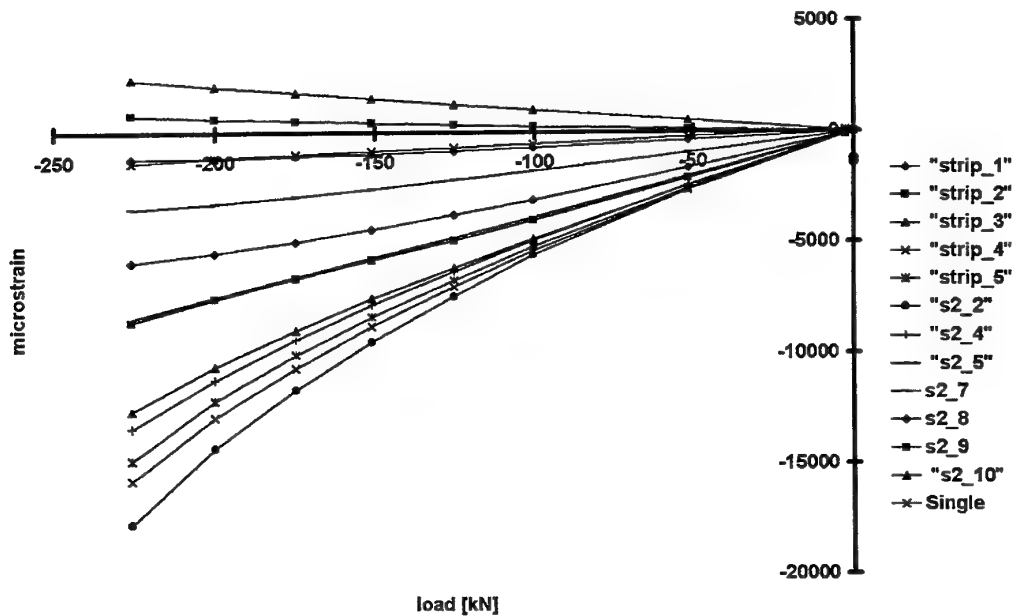
Figure 14: Strain vs load results for all strain gauges during compression loading up to point of buckling. Strip_x denoted Kyowa gauges. s2_z denotes Micro-Measurements gauges. The single gauge is a Micro-Measurements gauge.

The strip gauge element s2_2 reached a strain of $-17776 \mu\epsilon$ at -226 kN - the last measurement before buckling at approximately 248 kN . As the gauges had been zeroed, an additional strain equal to the gauge offset at the end of the tension loading should be added. This additional value is $2410 \mu\epsilon$.

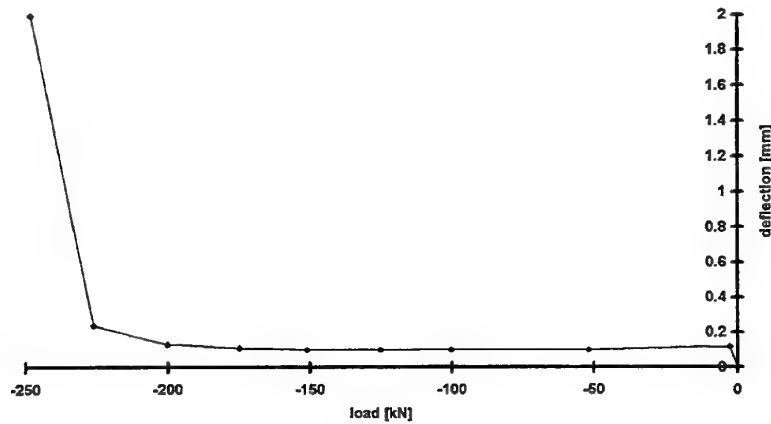
Figure 15: Load vs out of plane deflection showing onset of buckling

The test specimen reached a load of 248 kN . This was a lot lower than the value predicted, so it came as a surprise. Figure 15 shows the out of plane deflection versus load during the compressive cycle.

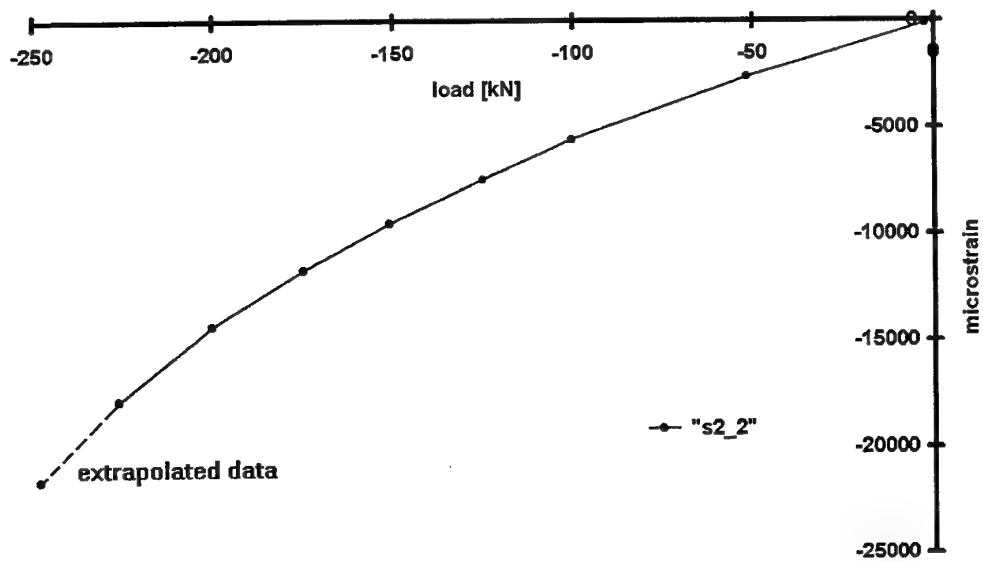
Figure 16: Load vs strain at gauge element s2_2 showing extrapolated data (if no buckling had occurred)

The response of gauge element s2_2 is given in Figure 16 with the line extrapolated out to 250 kN . It is easy to see that the specimen was very close to reaching the target $21549 \mu\epsilon$.

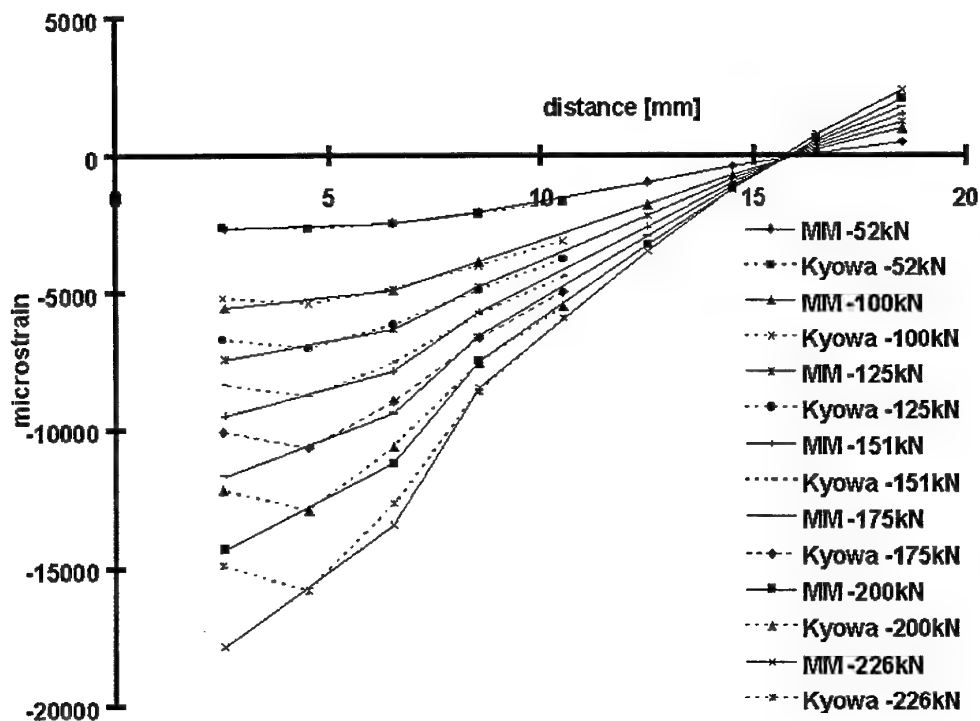
Figure 17: Strain gauge comparison between Kyowa and Micro-Measurements gauges at different load steps.

The response of the Kyowa and Micro-Measurements gauges can be compared side-by-side as shown in Figure 17 at different load values. Values are plotted around the radius with the zero being the tangent between the radius and the flat side of the hole.
